June 30, 2020
Kleinfelder Project No.: 20180666.071A

**SUBJECT: JUNE 2020 SEMI-ANNUAL BARRIER MONITORING
MURRAY COSTCO WHOLESALE WAREHOUSE #764
5201 SOUTH INTERMOUNTAIN DRIVE
MURRAY, UTAH 84107**

Attachment A: June 18, 2020 Inspection Records:
Barrier Inspection Checklists
Barrier Inspection Map
Storm Drain Inspection Checklist

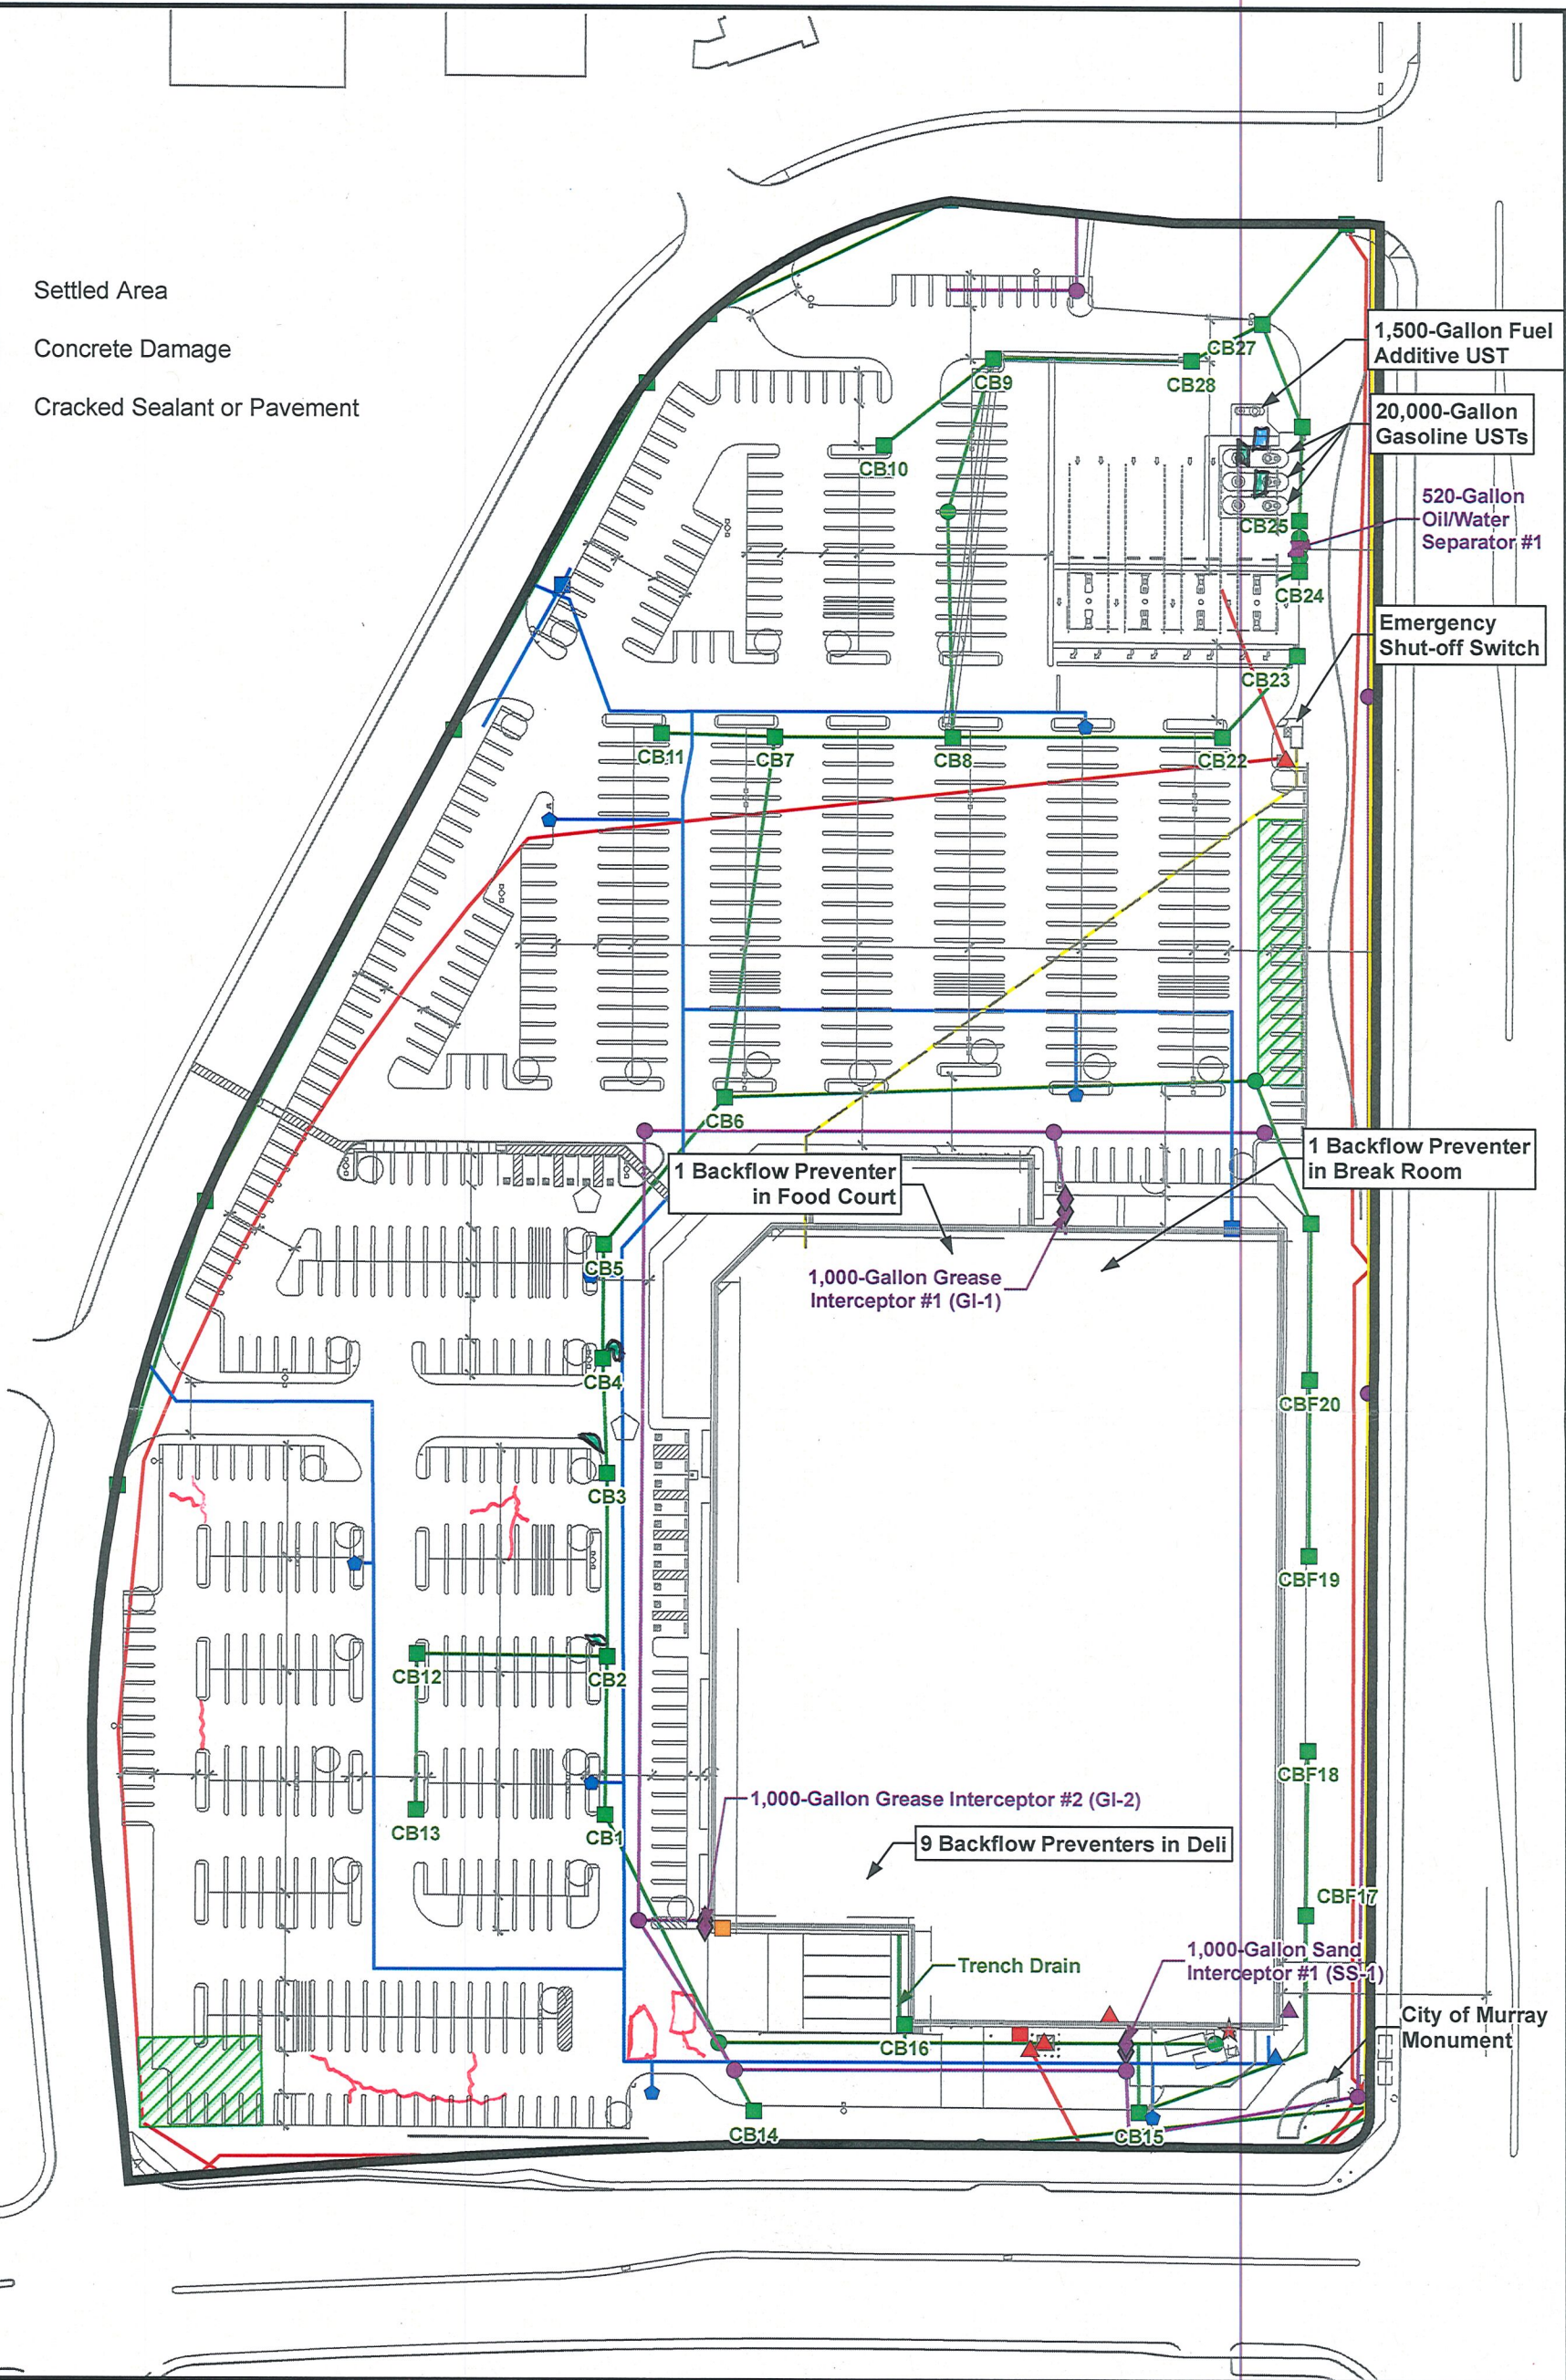
FIGURE

One small area of concrete damage, approximately 6 inches in diameter, was observed in the northeast portion of the gas station and two small areas of concrete damage, up to 8 inches in diameter, were observed in the curbs next to the stormwater catch basins CB2 and CB3. The concrete damage did not extend to, or expose, the underlying soil. The remainder of the concrete barriers were in good condition, including sidewalks, curbs, and gutters, loading platforms, and parking areas. Large cracks and separations were not identified during our inspections of the sealed joints (present at the fuel center).

Observations/Comments: THE CONCRETE APPEARED TO BE IN GOOD
CONDITION, WITH MINOR CONCRETE DAMAGE OBSERVED
IN THE TRUCK DECK AREA AND NORTH WEST OF THE
WAREHOUSE.

Observations/Comments: FEW AREAS OF MINOR ASPHALT PAVEMENT
DAMAGES WERE OBSERVED, WITH MINOR CRACKED SEALANT
OBSERVED IN A FEW LOCATIONS. HOWEVER, THE PAVEMENT
WAS GENERALLY OBSERVED TO BE IN GOOD CONDITION.

Observations/Comments: FEW AREAS OF MINOR ASPHALT PAVEMENT
DAMAGES WERE OBSERVED, WITH MINOR CONCRETE SETTLING,
CRACKED SEALANT PAVEMENT OBSERVED.

- Settled Area
- Concrete Damage
- Cracked Sealant or Pavement
